NASA TECHNICAL  
MEMORANDUM

June 28, 1974

NASA TM X-64815

MSFC SKYLAB APOLLO TELESCOPE MOUNT  
SUMMARY MISSION REPORT

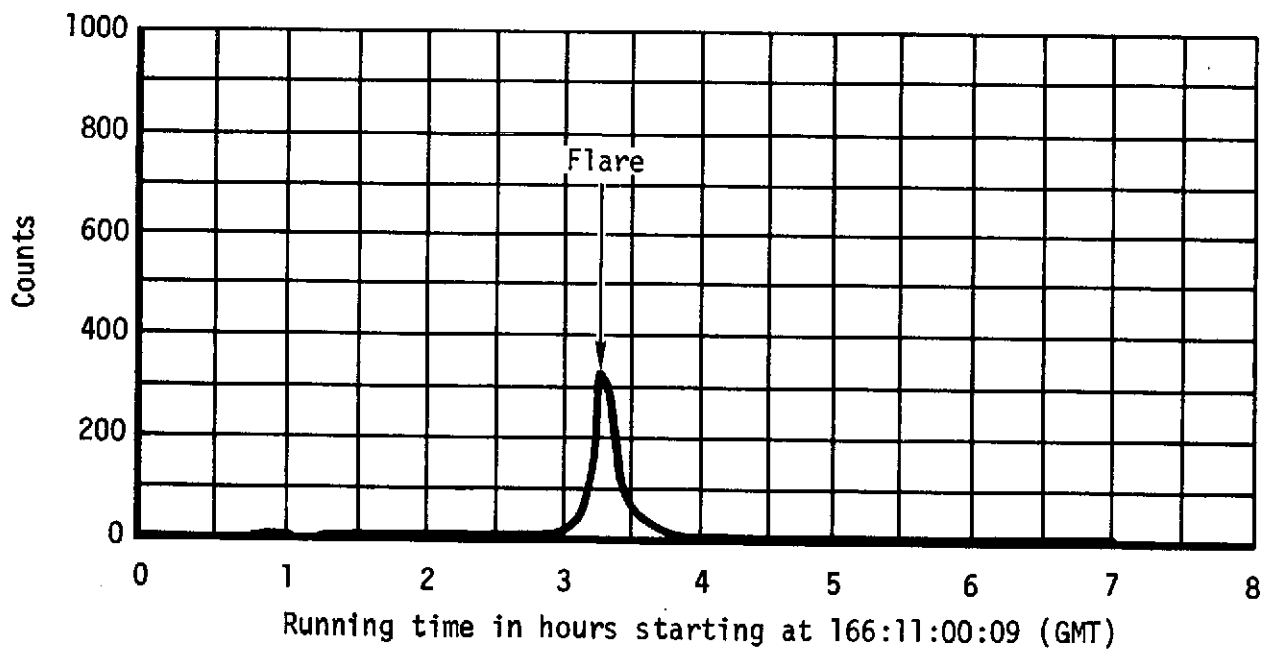
Figure 3-7. S054 X-Ray Intensity Monitor Radiation Response

The system functioned as designed; however, false flare alarms were generated by the high energy radiation in the South Atlantic Anomaly.

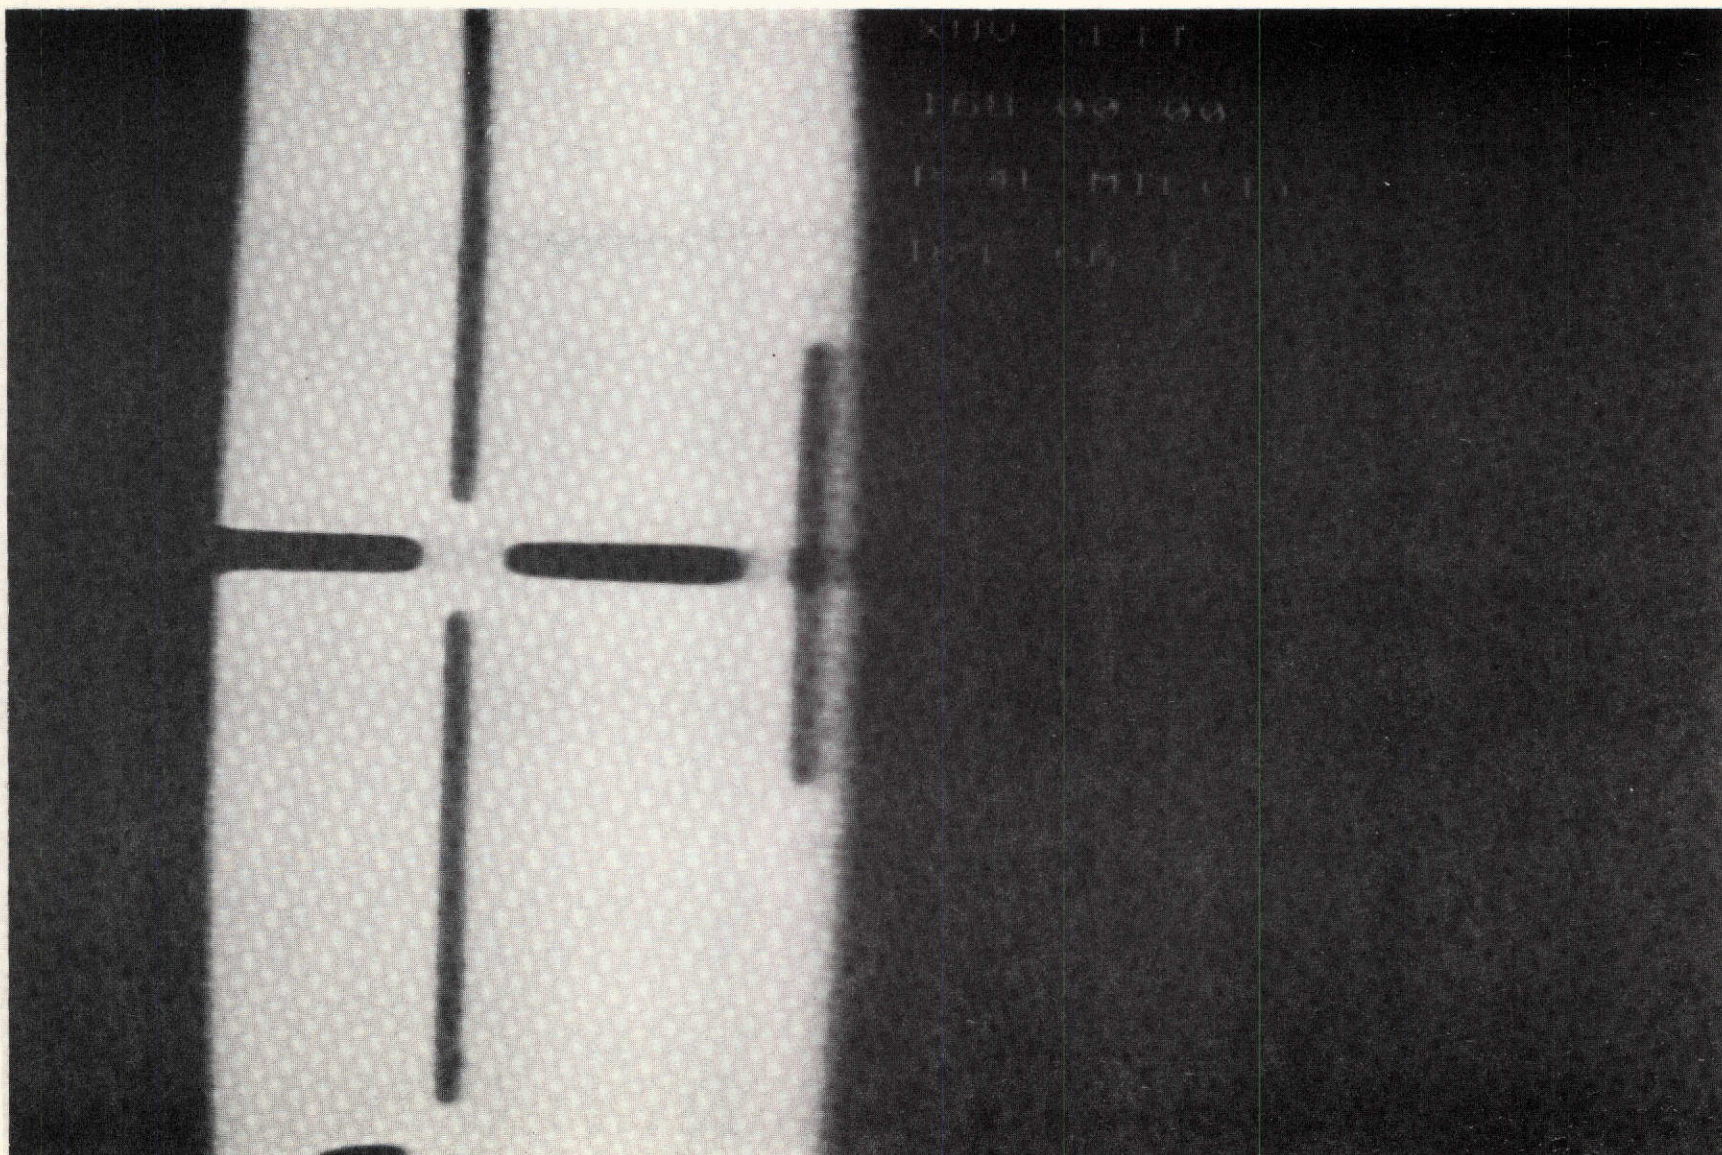
Figure 3-16. S082B White Light Display Downlink Photographs

The crew indicated the white light display presentation on the monitor was of less than optimum quality but sufficient for accurate pointing capability. The pointing reference system remained stable throughout Skylab 2 and 3. However, during Skylab 4 some degradation was evident. Sensitivity of the system had decreased so that the pointing reference system could not be used for limb pointing or limb scanning. The ATM experiment pointing control was used thereafter for S082B limb pointing. A representative downlink photograph of the white light display is shown in figure 3-16.

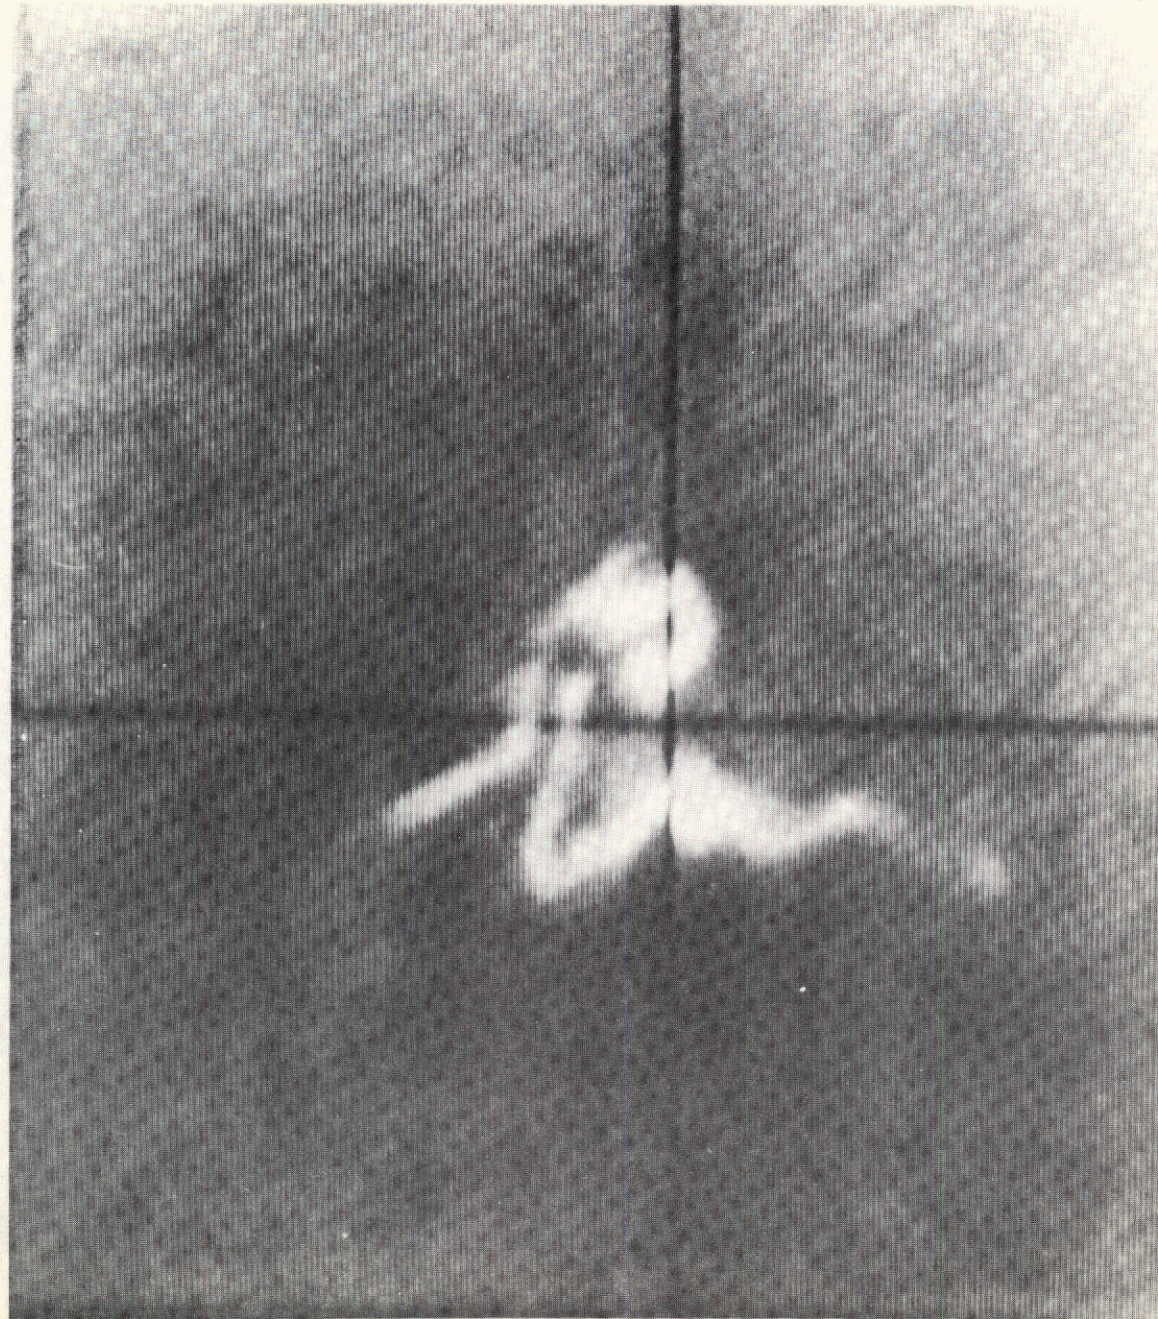
Figure 3-19. H-Alpha 1 Television

Television imagery remained stable throughout the mission except for some degradation evident on H-alpha 1 during the last month of the mission. It was found that the H-alpha 1 image significantly improved when the vidicon was left off for a period of 8 hours. Thus, the crew was instructed to leave the H-alpha 1 television camera powered down when not in use. Figures 3-19 and 3-20 are photographs of downlink television images taken on DOY 166. Table 3-12 lists the H-alpha television resolution parameters. In all cases the resolutions obtained were equal to or better than the design specification.

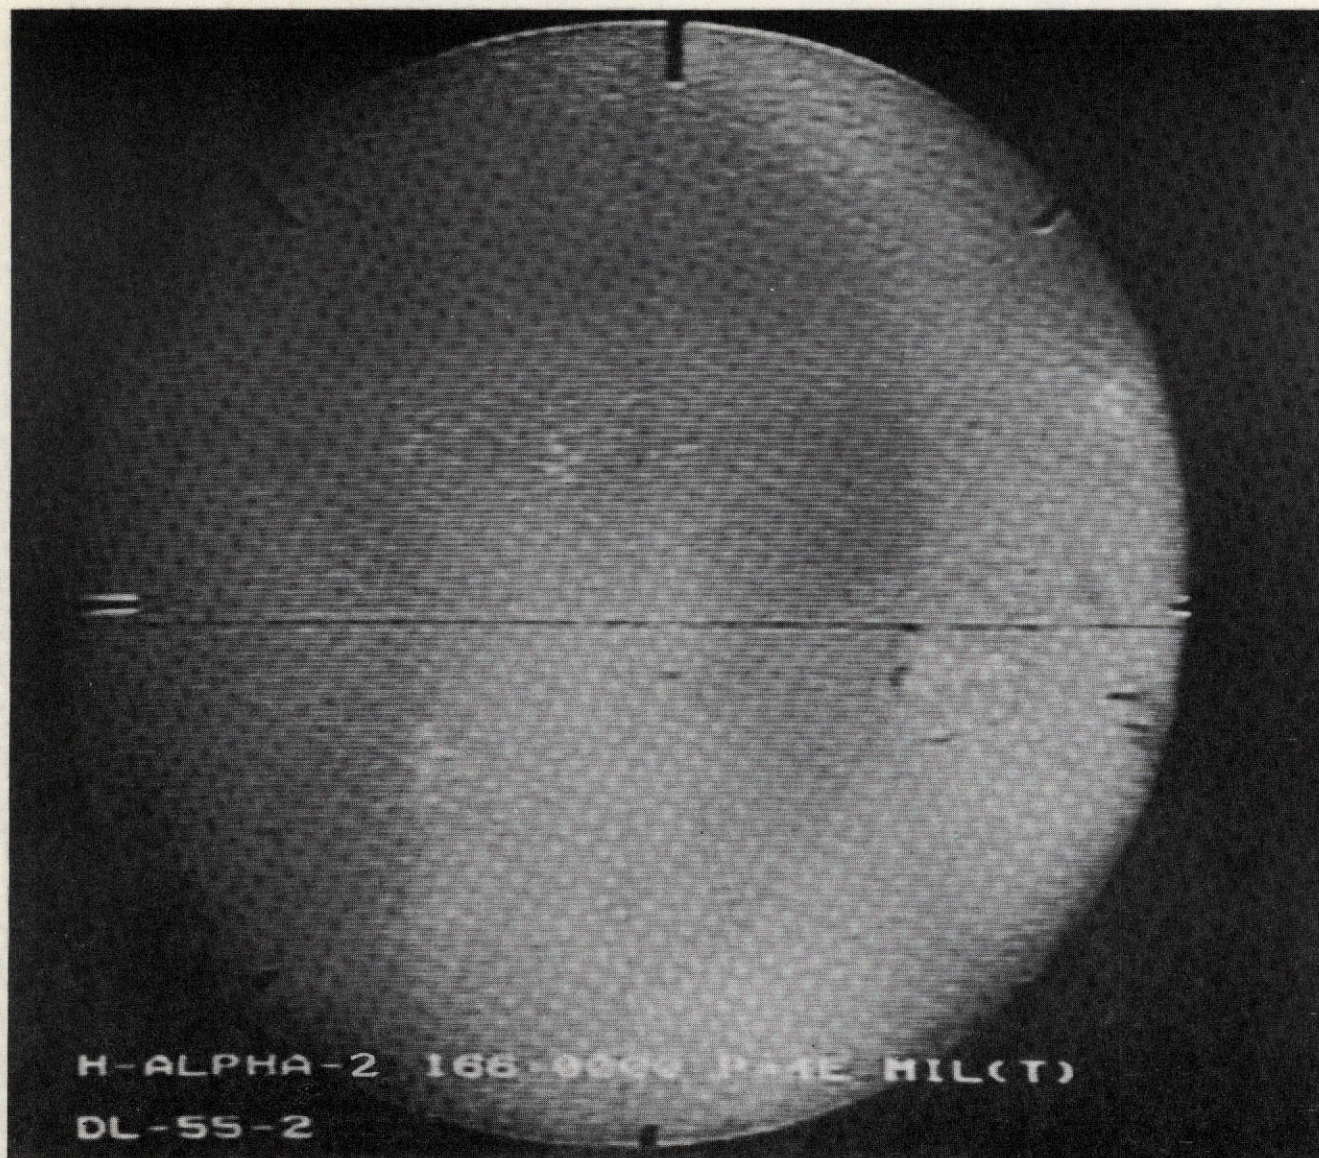
Figure 3-20. H-Alpha 2 Television

The H-alpha 2 television system exhibited some anomalous behavior such as image persistence and blossoming. However, these did not impact any solar observations.

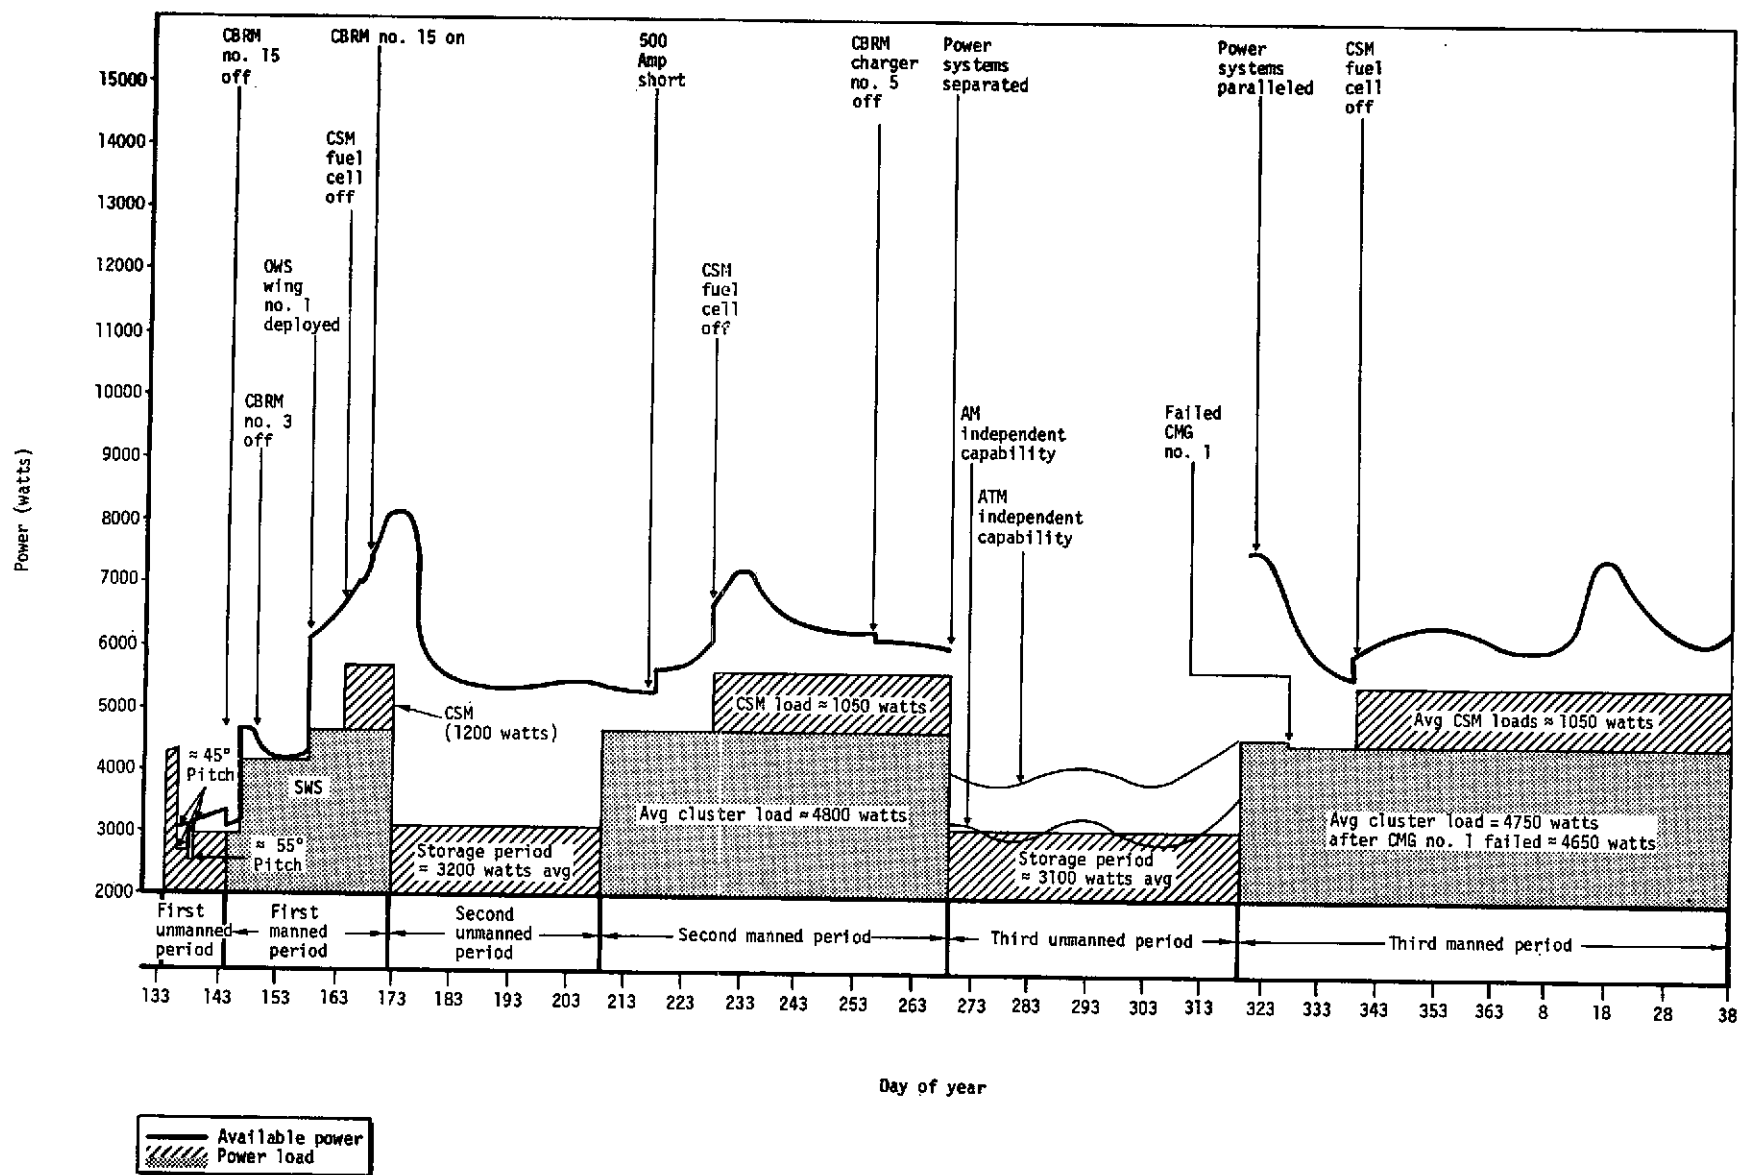
Figure 3-21. Skylab EPS Capability/Load History

ponents. Figure 3-21 shows the average system capability for the Skylab 2 unmanned phase. During this time, the loads were adjusted to ensure the load requirements did not exceed the capability of the electrical system.

Skylab 4 - The ATM and AM power systems were operating independently from DOY 269 to DOY 320, as shown in figure 3-21, during the unmanned period of the Skylab 4 mission. The average ATM load requirement during the unmanned period of Skylab 4 was 2000 watts and the average Skylab capability varied from a minimum 3800 watts to a maximum 4900 watts at the launch of Skylab 4. The resulting battery depth-of-discharge for the 2000-watt load over the range of Beta angles encountered during the unmanned period varied from 12 to 14 percent. Since a large positive power margin was indicated on both systems for the entire unmanned period, daily load predictions were not computed.

The ATM and AM electrical systems were paralleled on the first day of Skylab 4 activation and the AM open-circuit voltage was adjusted to 29.1 volts and then was increased to 29.3 volts for the remainder of the activation period. The power system capability of the two systems operating in parallel at the 29.1-volt open-circuit voltage was 8000 watts. The adjustment to 29.3 volts decreased the cluster capability to 7900 watts. As the cluster was activated the load increased incrementally until at the end of the activation period the load was 4800 watts average when the crew was awake and 4200 watts during the crew sleep period. Compared to the 7900-watt capability for this period a minimum power margin of 3100 watts existed. The power system capability for this period is shown in figure 3-21.

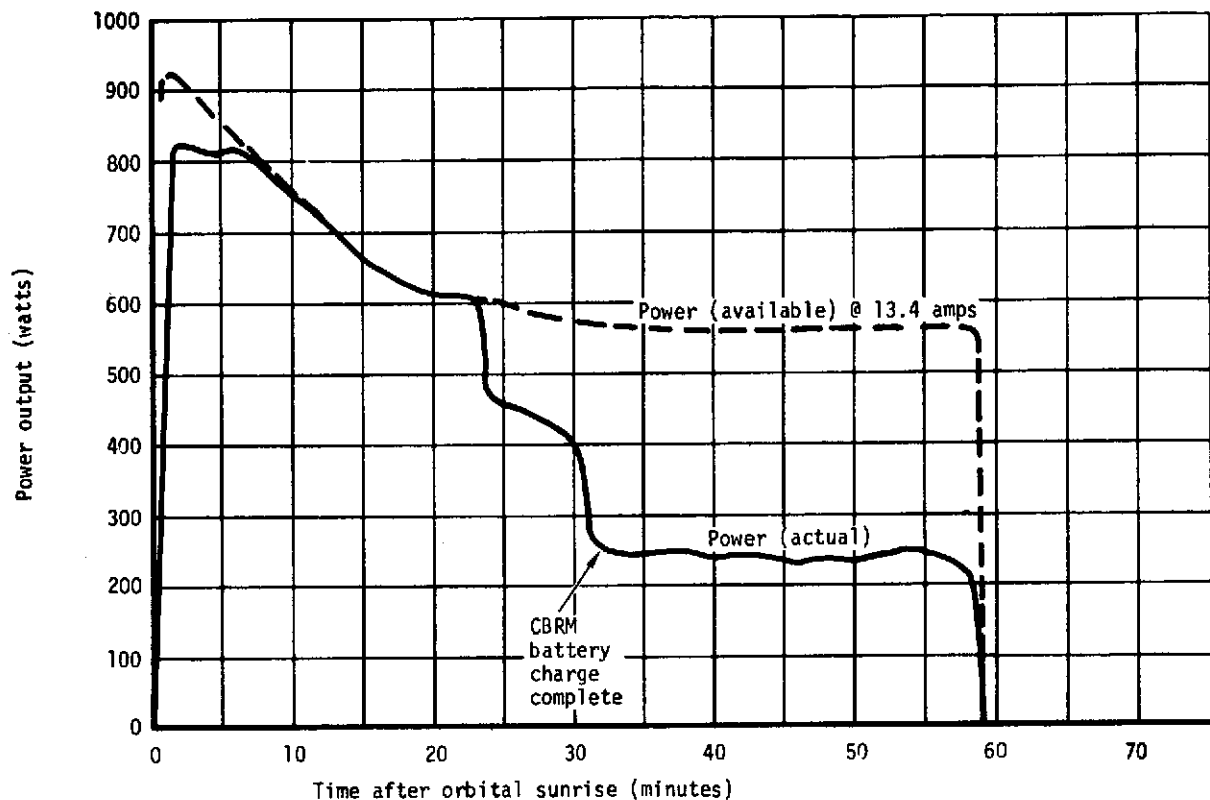
Figure 3-22. ATM Solar Panel Capability vs CBRM Requirement

Solar Panel Capability at End of Mission - The ATM solar array was not required to produce full power output for the full sunlight duration, even under periods of high ATM power requirements. Figure 3-22 shows a typical plot of power output versus time for panel 710A5. At 30 minutes after sunrise, battery charging was complete and the panel output was reduced. Also shown in the figure is the estimated power output at 13.5 amperes over the complete illuminated portion of the orbit. From this data it can be found that the actual watt-hours output was only 74 percent of the watt-hour capability. Therefore, in this case, the panel could have supplied 26 percent more electrical energy if required.

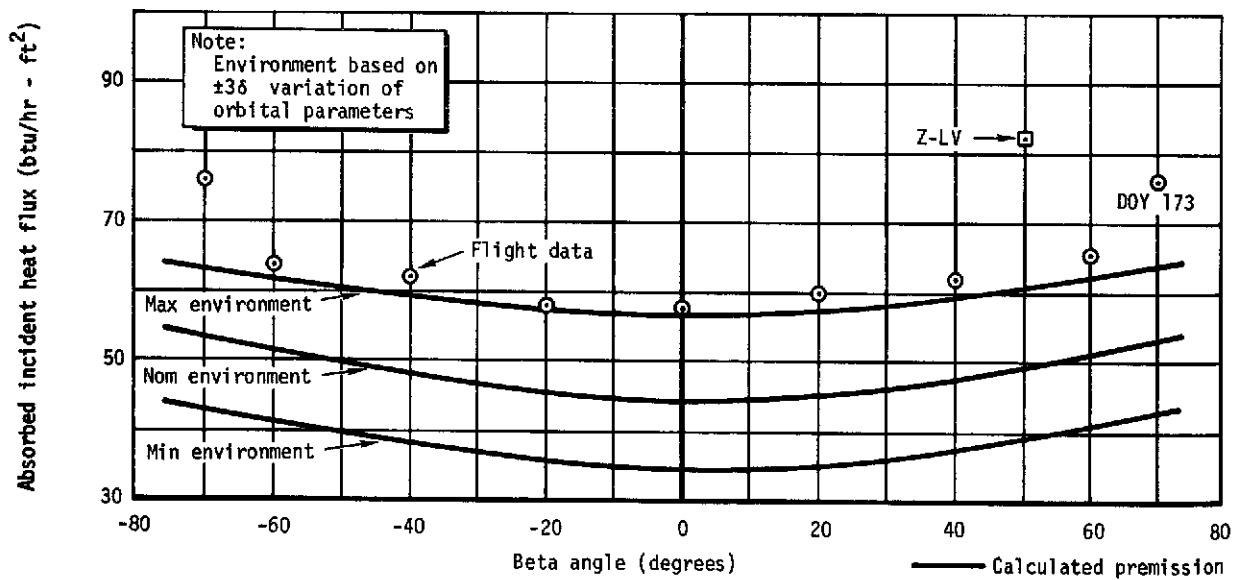
Figure 3-24. Radiator Total Average Absorbed Incident Heat Flux vs Beta Angle

Figure 3-24 compares the premission and the actual calculated heat fluxes on the radiator of the thermal control system. The maximum and minimum predictions were based on a  $\pm 3$  sigma variation from nominal environments, and a degradation in the coefficient of solar absorptivity to 0.5 for the S-13G thermal coating. At the time when the canister inlet reached 284.8 kelvins, the radiator outlet temperature was at its maximum of 284.4 kelvins. The higher-than-expected temperatures can be attributed to two factors: external heat fluxes higher than anticipated, and elevated internal heat loads due to unexpectedly high solar shield temperatures and latched-open aperture doors. However, due to the margin inherent in the system, no temperature limits were violated, nor were functional problems experienced. After DOY 018, with decreasing Beta angle, the radiator outlet and canister inlet temperatures decreased to normal values.

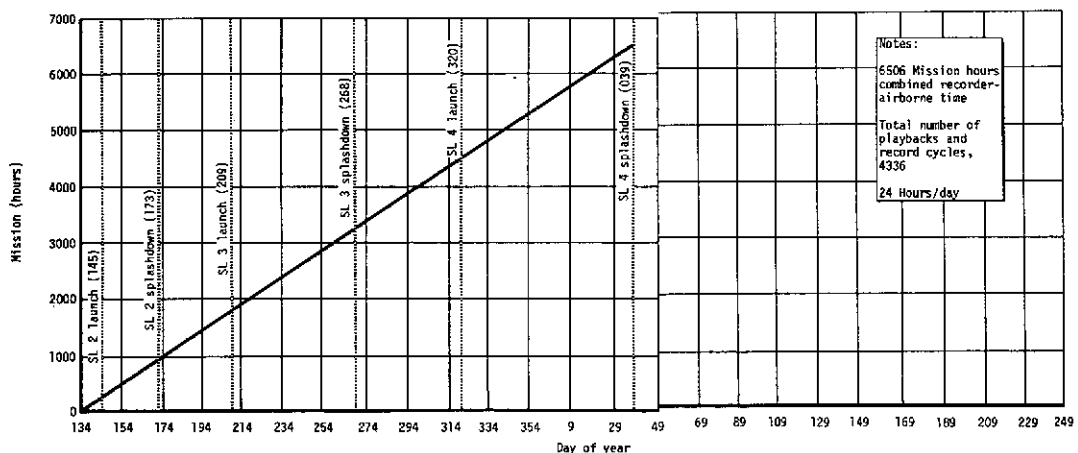
Figure 3-25. ATM ASAP Tape Recorder Status

The spacecraft was flown in non-solar-inertial attitudes to control workshop temperatures during the early portion of the mission. This created extreme temperatures on the auxiliary storage and playback tape recorders, constraining operation to cyclical operations to allow one to cool while the other operated. Tape recorder number 1 reached 302.1 kelvins and recorder number 2 reached 305.2 kelvins. The upper redline limit was 303.2 kelvins. After the spacecraft returned to the solar inertial attitude, normal operations were resumed with no degradation to the recorders. The ATM tape recorder status for the mission is shown in figure 3-25.
